Security Council

S/23215
14 November 1991

REPORT ON THE SEVENTH IAEA ON-SITE INSPECTION IN IRAQ
UNDER SECURITY COUNCIL RESOLUTION 687 (1991)

11 - 22 October 1991

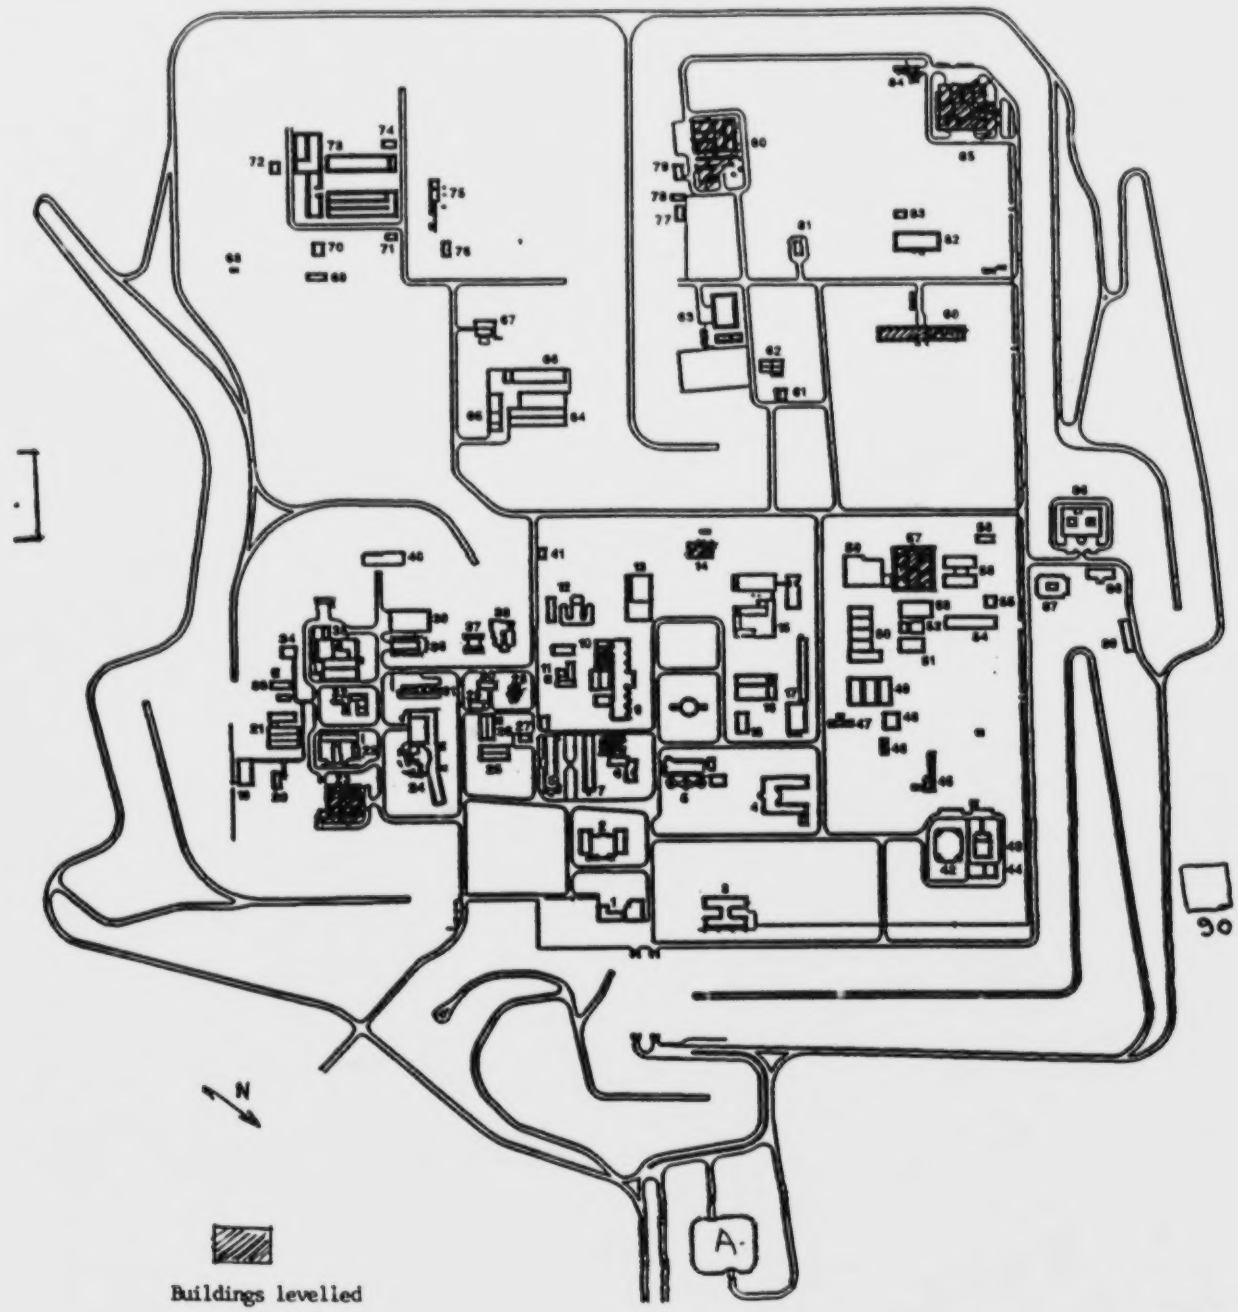
Figure 3

14. It has been determined and documented that work covering the various phases of uranium metallurgy was conducted at Al Tuwaitha prior to the destruction of the relevant facilities. Buildings 10 and 15 were used for $UF_4$ production, uranium metal reduction and metal casting and machining (see Table 1 and Fig.3).

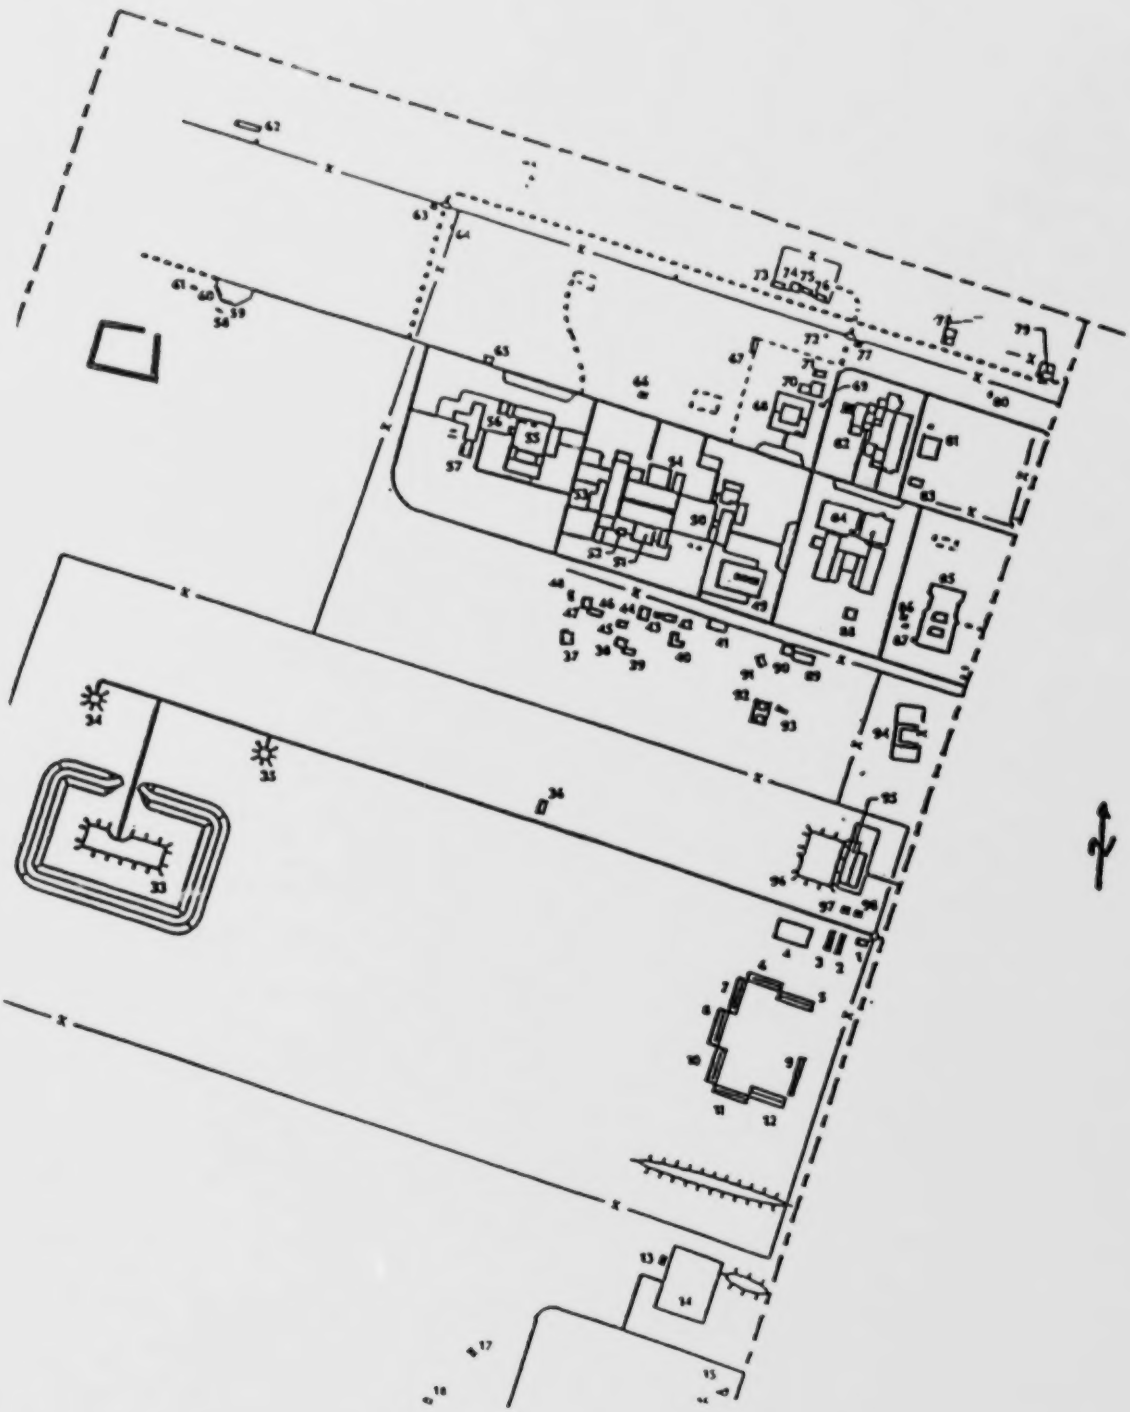
Figure 4

15. The IAEA inspection team confirmed, through documents and on-the-spot visual evidence, that the Al Atheer facility (fig. 4) was designed, inter alia, for large-scale uranium metallurgy. Induction furnaces, plasma coating machines, computer-controlled drills and lathes with recoverable chippings were identified in Buildings 50 ("casting"), 55 ("powder") and 84 ("carbide"). Smears and samples taken during the seventh inspection will indicate whether those facilities were used between July 1990 (date of completion of Building 55) and December 1990 (date when the facilities were evacuated prior to bombardment).

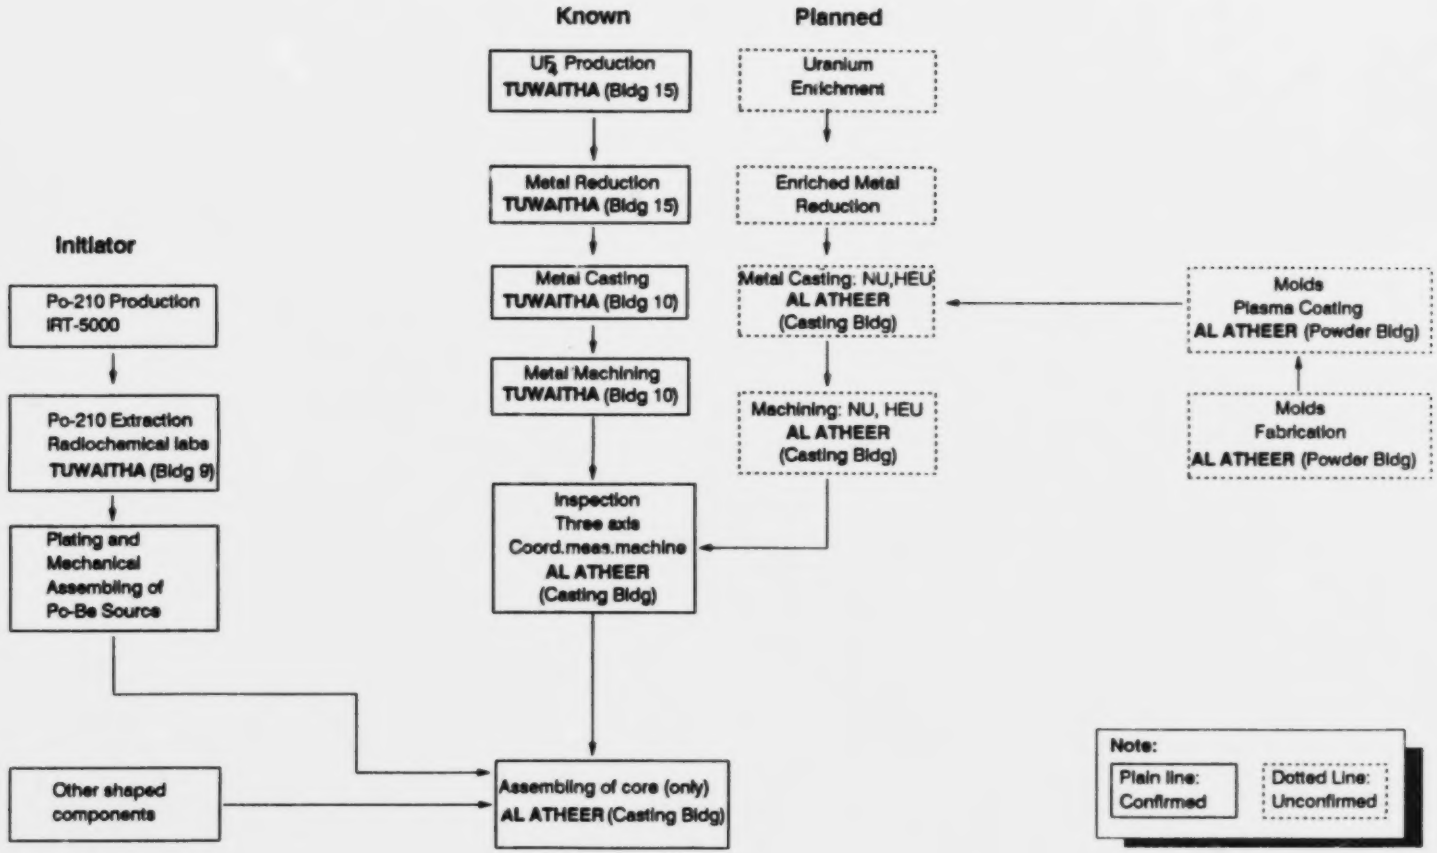
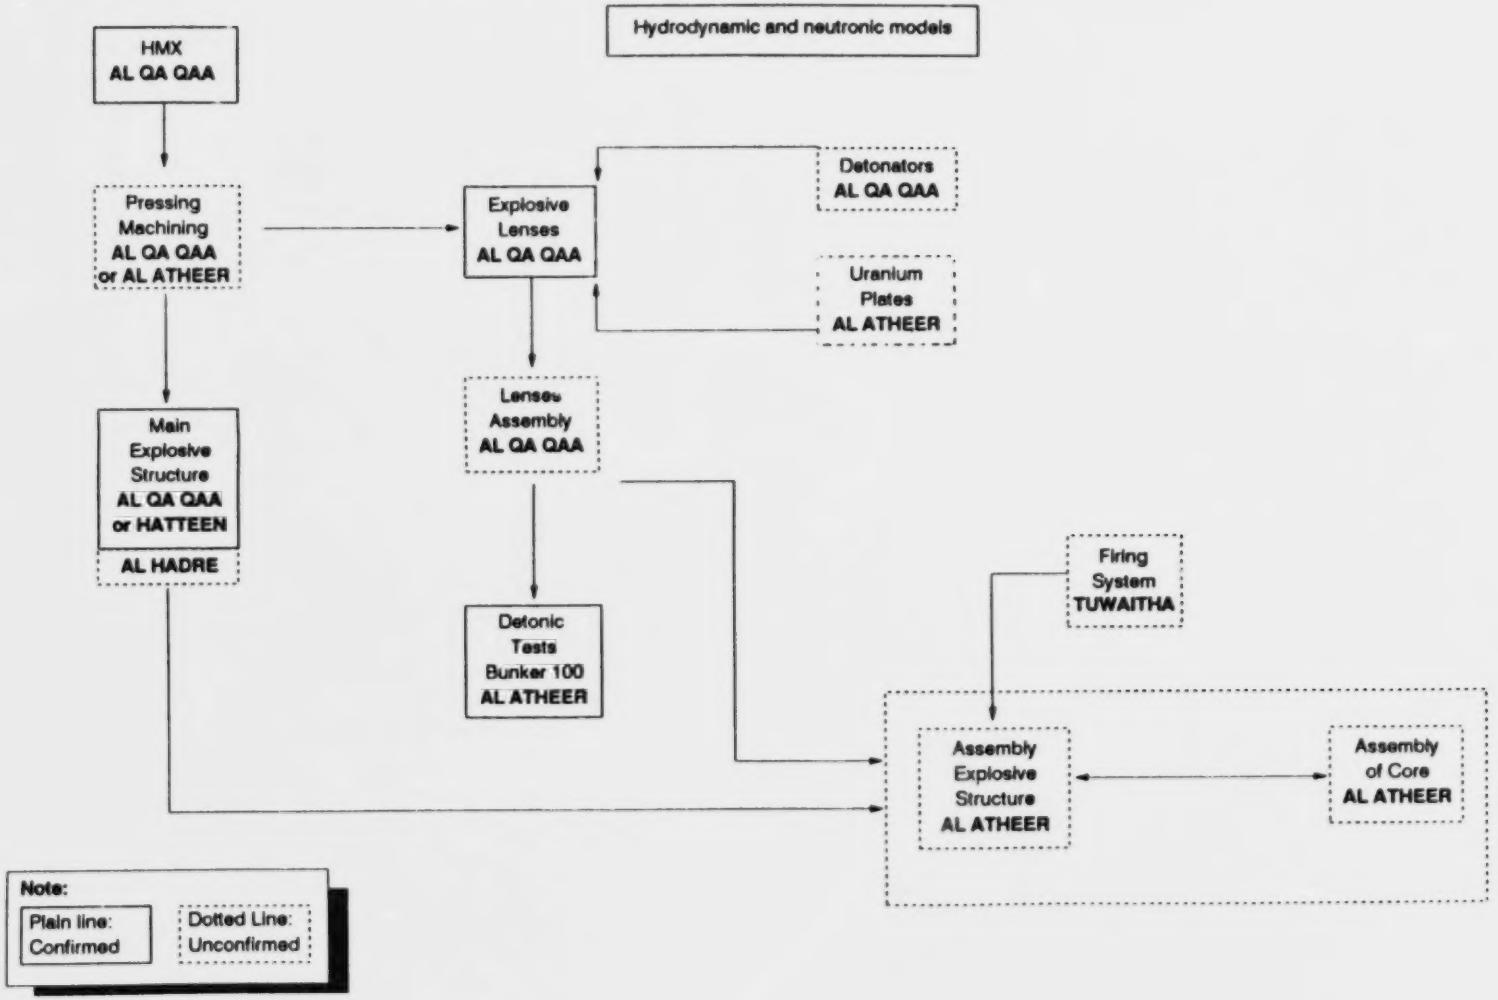
25. To the best of the team's knowledge, based on Iraqi progress reports found and on the results of the IAEA inspections in the field, the status of the Iraqi work on the various pathways leading to nuclear weaponization is as shown in Figures 5 and 6; it can be summarized as follows:

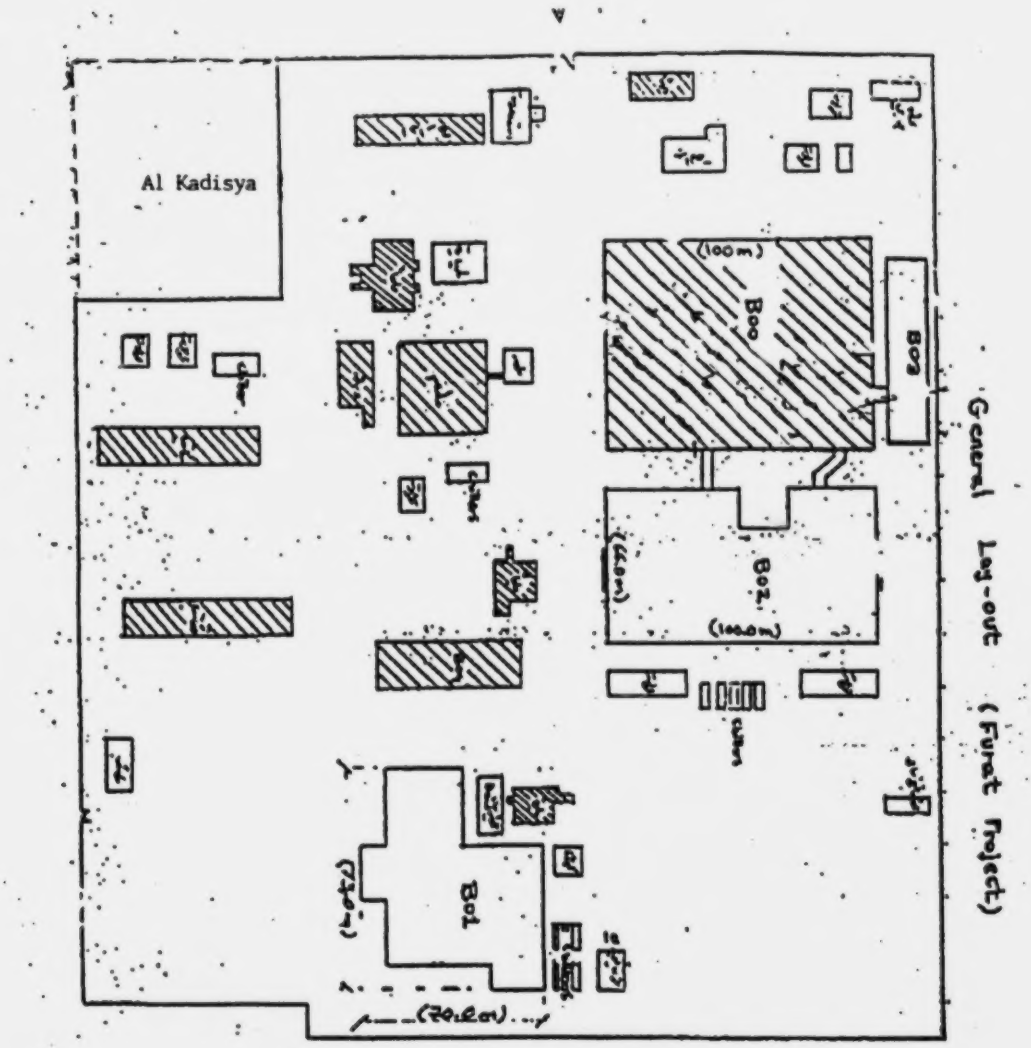
Figure 7

THE AL FURAT CENTRIFUGE PRODUCTION COMPLEX

57. The Al Furat site was originally a school for technicians. The training area (now designated as Building 800) had been reconfigured for the centrifuge manufacturing program. The remaining buildings are barracks and small support buildings. These buildings are unused. The north-east corner of the Al Furat site contains a separately fenced area (fig. 7). When the team requested access to this area for inspection purposes, the Iraqi authorities stated that the area belonged to another firm (the Al Kadisya State Establishment) and that a formal designation was required. This was quickly arranged, and the inspection proceeded. The area used to be part of the technician training centre that comprised the Al Furat site. The three larger buildings in this area are two barracks and a warehouse/storage building. The barracks are essentially untouched. Several rooms are being used as offices. The warehouse has been converted into a small machine shop used for some rudimentary robotics development work.

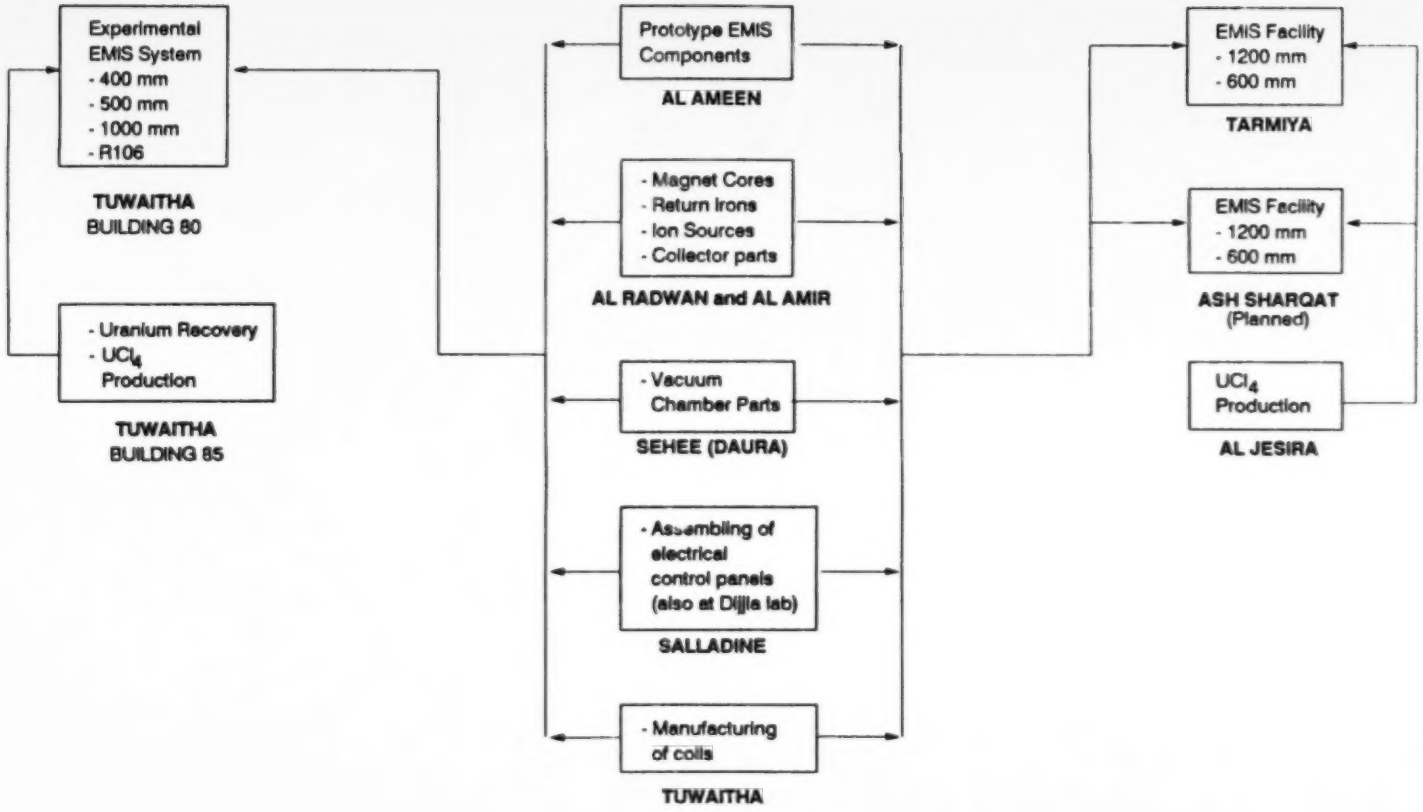
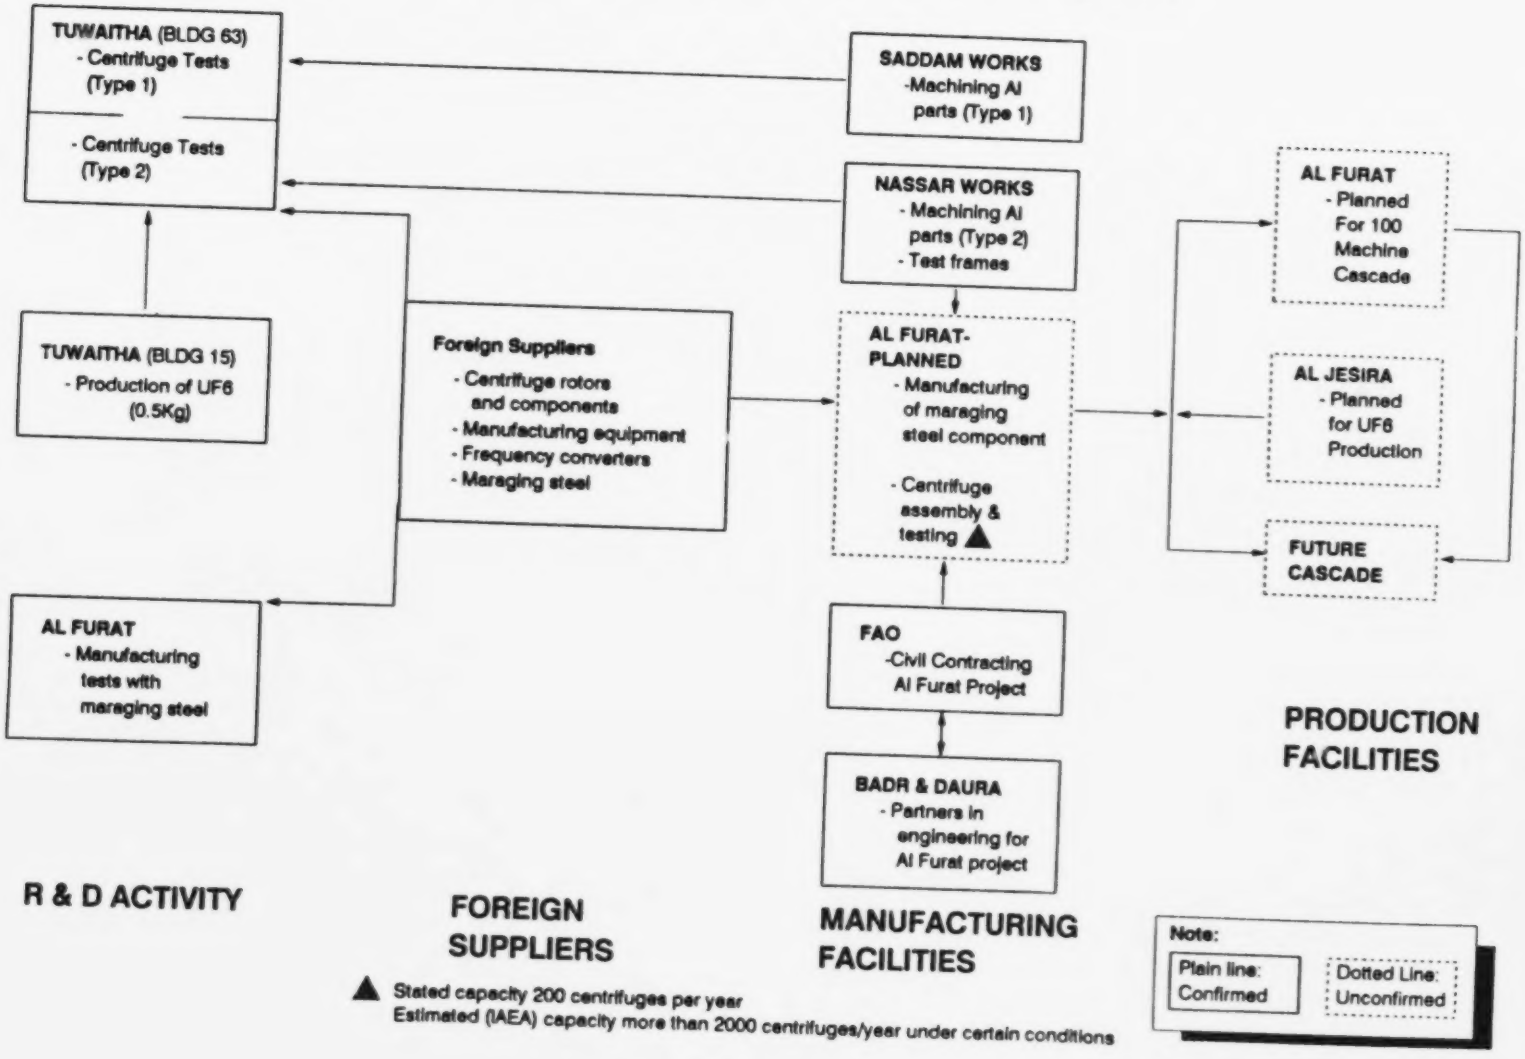
33. Schematics describing the R&D, manufacturing and production facilities for EMIS and centrifuge enrichment are given in Figures 8 and 9. A detailed description of the Iraqi uranium enrichment program is provided in Annex 4. The sites involved in EMIS development (Al Tuwaitha and Tarmiya), component manufacture (Al Radwan, Al Amir, Dijla and SEHEE) and production (Tarmiya, Ash Sharqat and Al Jesira) have been identified. All facilities were badly damaged during the war. The conclusion of the third inspection team that the Ash Sharqat facility never operated has been confirmed.
